EASYkleen

Technical handbook for the post weld treatment of stainless steel

**An easy to read and follow technical handbook which
summarizes various collaborative reports and studies from
leading Universities and materials testing companies**

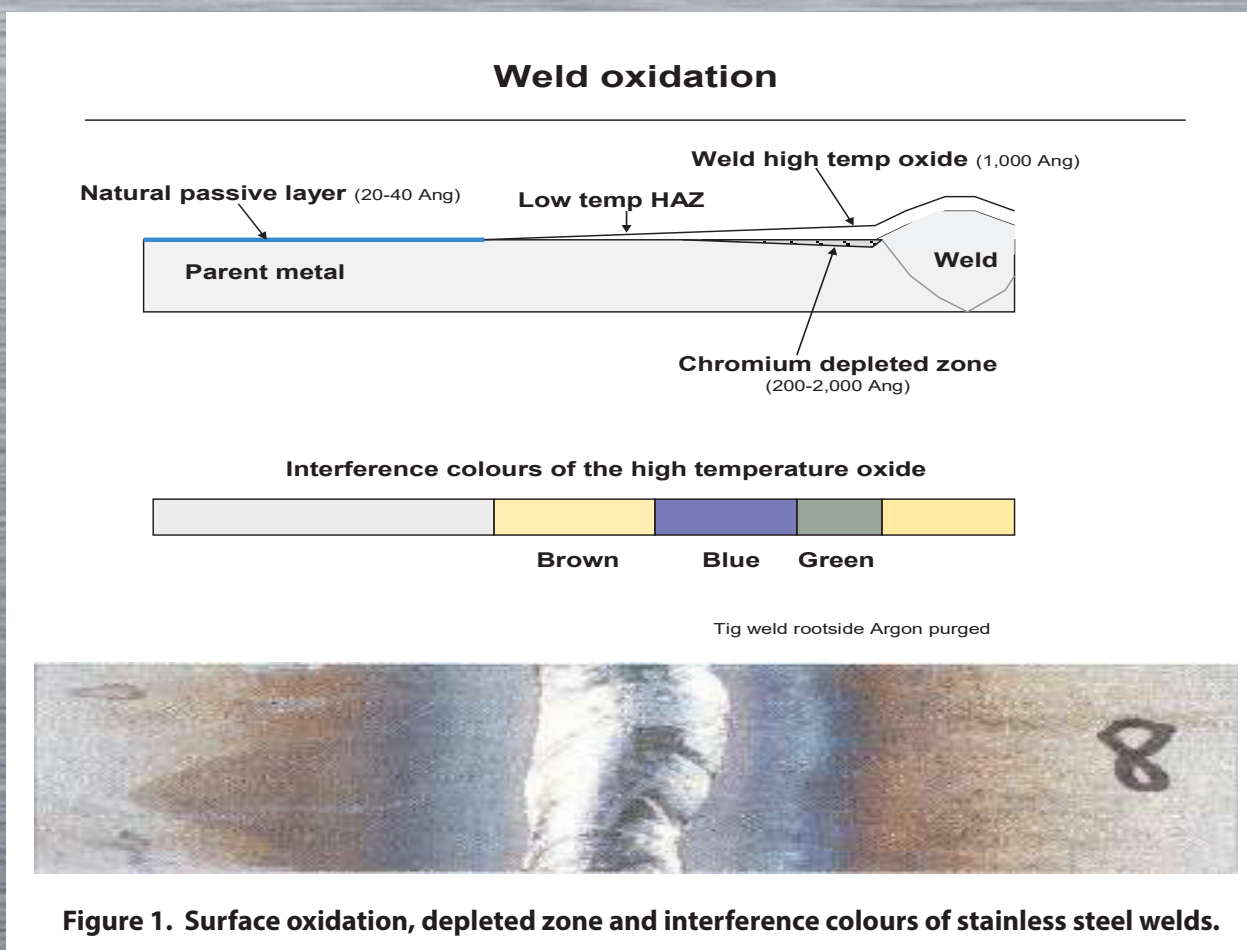
When stainless steel is welded, the high temperature heat affected zones (HAZ) are the result of chromium depletion at the surface through chromium carbide precipitation (Cr_{23}C_6). The stainless steel within this chromium depleted area or zone is left with diminished or no protection from corrosion. The surface oxidation and chromium depleted zone, along with interference colours caused by metal oxides are represented in Figure 1.

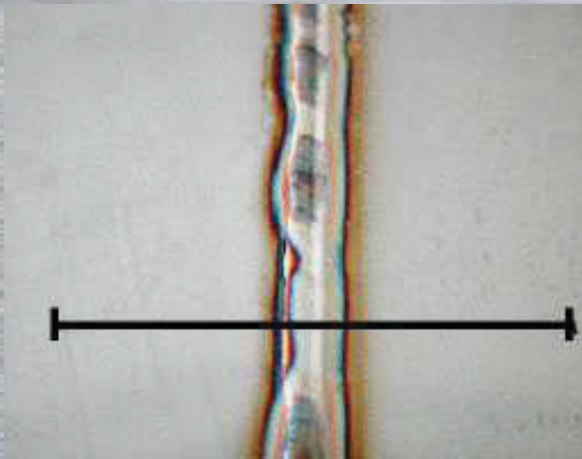
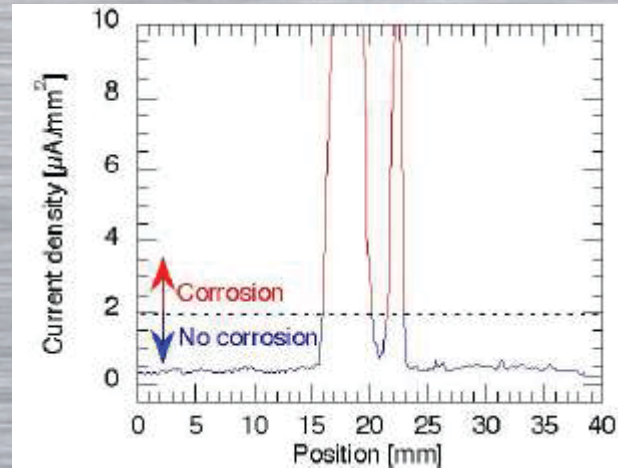
Fig. 2 : Potentiostatic line scan over a weld in a 304 stainless steel test piece showing the variation in corrosion current.

In Figure 2 a porous tip is positioned on the surface of the sample through which a salt electrolyte (0.1 M NaCl) is allowed to flow whilst a control unit holds the tip at a constant 260 mV as it measures the current flow to the sample. The tip size is 1.5 mm². Significant increases in current are seen as the tip passes over the weld, indicating that these regions are much more susceptible to corrosion than the parent metal.

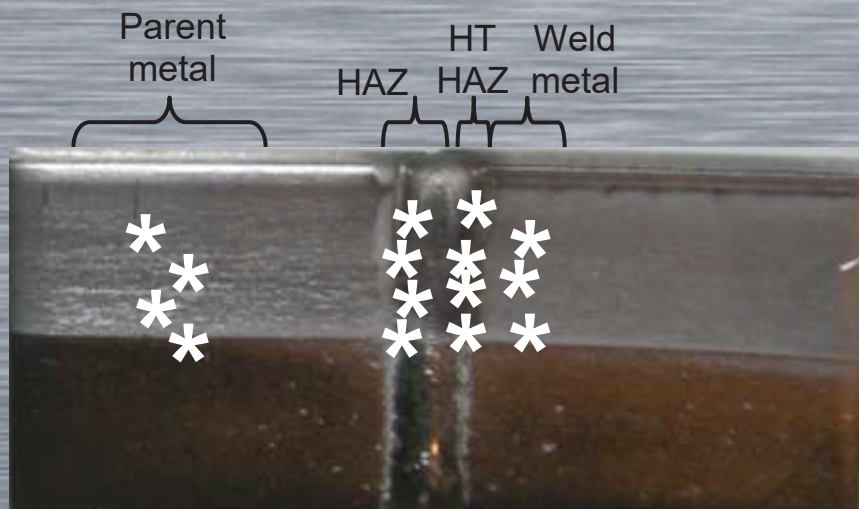
Figure 3. Location of Pitting Potential measurements

Pitting potential measurements were made on the parent metal, the heat affected zone (HAZ) within 4mm of the weld fusion boundary, the high temperature heat affected zone (HTHAZ) at the fusion boundary and on the weld metal of each sample (Figure 3). The results show the pitting potential as a value in mV; the maximum value of potential obtainable by the test instrument was 737mV. The test method is quite sensitive to defects such as oxidized welds and inclusions etc.

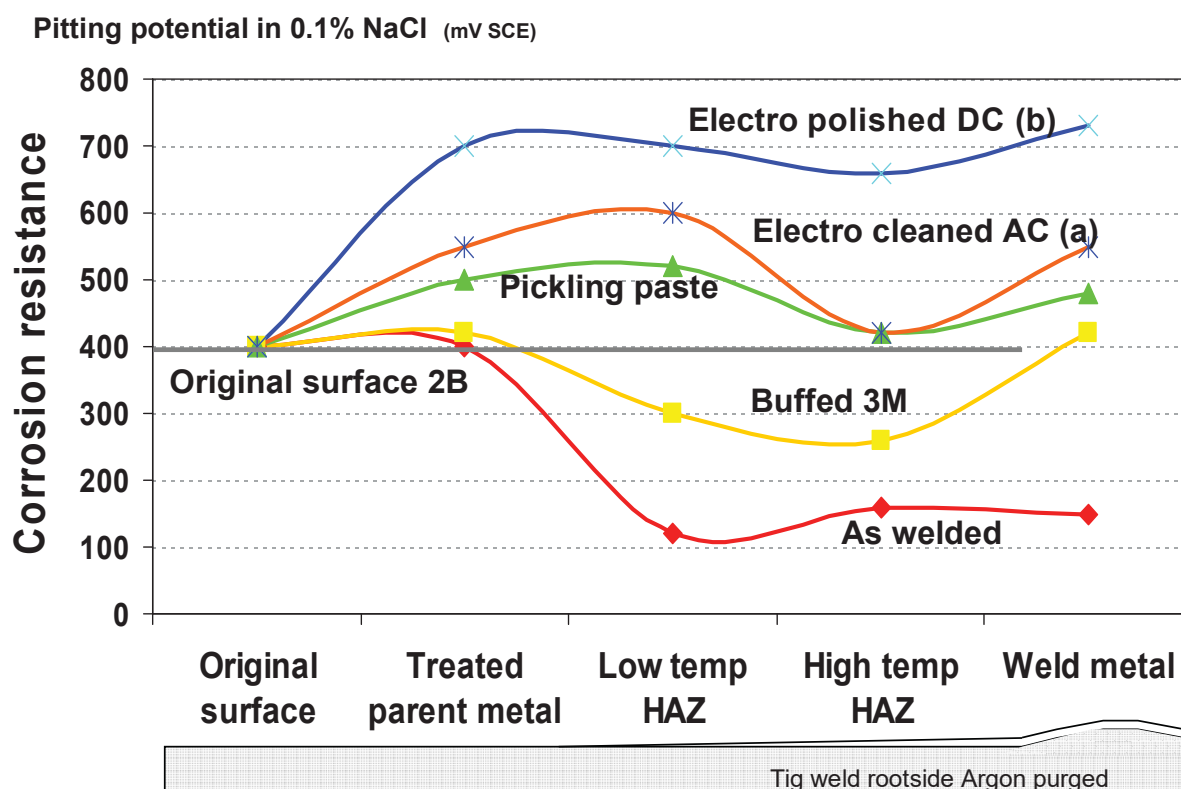
Post weld cleaning 316

These results are summarized in the following graph in Figure 4.

Figure 4. Effect of cleaning methods on a stainless steel weldment.

The two test methods employed to evaluate the effect of surface treatments on the pitting corrosion resistance of weldments produced similar results. These tests confirmed that all cleaning methods improve the corrosion resistance of the weldments, however mechanical abrasion has the least positive effect. The standard method used for cleaning weldments with pickling paste showed positive results, however it did not return the surface to the same level of corrosion resistance as the parent metal in the high temperature heat affected zone. The largest improvement in corrosion resistance was demonstrated by the mepBLITz with the carbon fiber brush, which exceeded the performance of the pickling paste and returned the overall corrosion resistance of the entire weldment close to and in some areas exceeding that of the parent metal.

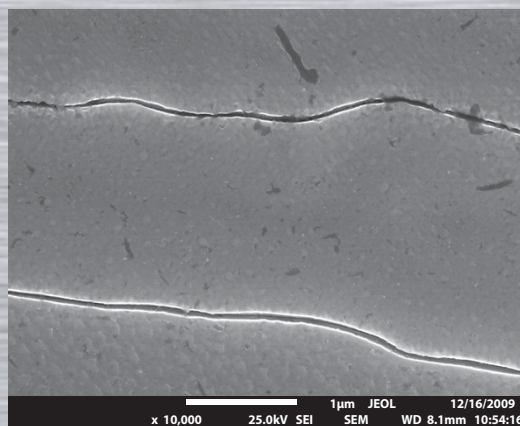
Pickling Paste

As mentioned in the Corrosion Resistance section of this booklet, pickling paste can restore some of the chromium which has been depleted from the welding process. However, it is unable to produce a smoothing effect like the electro-polishing process and will subsequently not provide the best possible corrosion resistance that can be achieved.

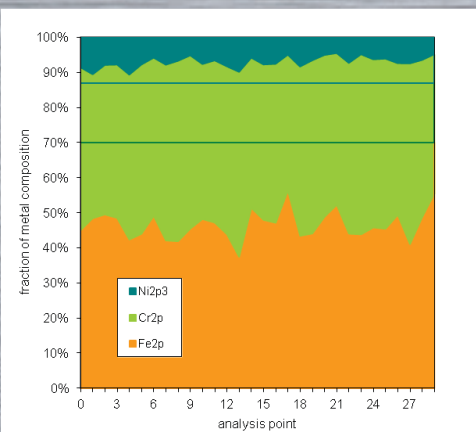
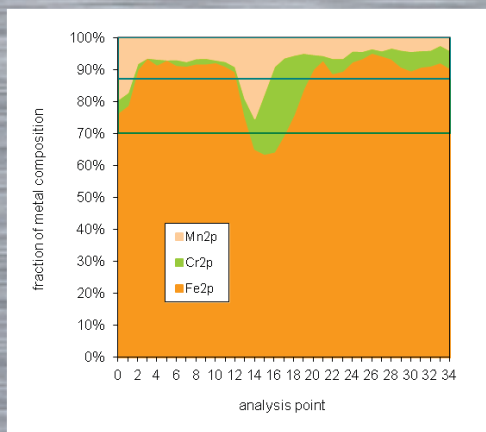
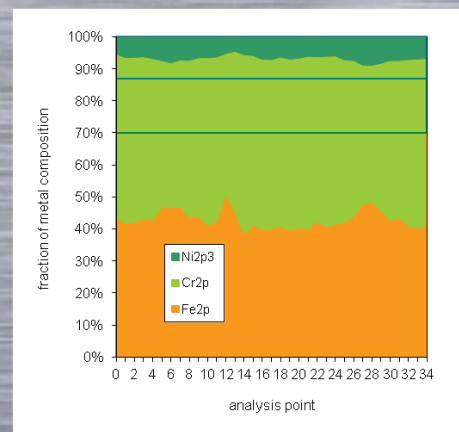
Figure 1A below illustrates the results of an XPS analysis of the surface of the steel prior to welding. This demonstrates that, as a fraction of the metals present on the surface, there is much more chromium present than there is in the bulk of the sample. The XPS data are also consistent with this being present in the form of chrome oxide.

Figure 1B represents the XPS analysis of an untreated welded sample. In this case the surface is almost all iron and manganese, with very little chromium present, which in part explains the poor corrosion resistance seen in such samples.

Figure 1C illustrates the XPS analysis of a welded coupon treated using the mepBLITZ and electrolyte B-30. Despite the presence of the weld, this sample looks almost identical to the parent metal (Figure 1A), indicating that this treatment has restored the protective chromium oxide layer on the metal surface.

Figure 1: Metal fractions at the surface of 316 samples determined using XPS analysis. A: Parent metal coupon, B. welded coupon, and C. welded coupon after treatment using the mepBLITz process. Horizontal lines indicate the composition of iron (Fe), chrome (Cr) and nickel (Ni) in bulk 316. Shaded areas in B and C represent the position of the welds.
